Evaluation Report 196

Will-Rich 13CPW (11.3 m) Heavy Duty Cultivator

WIL-RICH 13CPW CHISEL PLOW

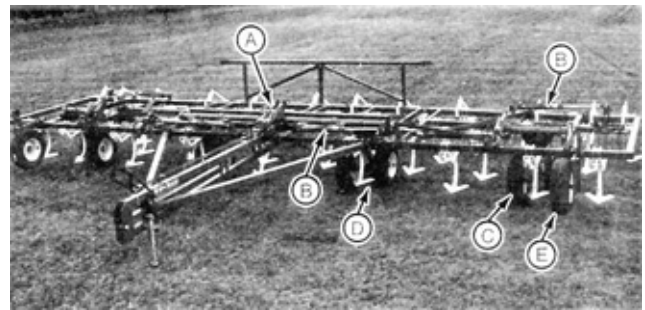
FIGURE 1. Wil-Rich 13CPW: (A) Depth Control Cylinders, (B) Wing Lift Cylinders, (C) Tandem Wing Wheels, (D) Tandem Centre Wheels, (E) Wing Stabilizer Wheels.

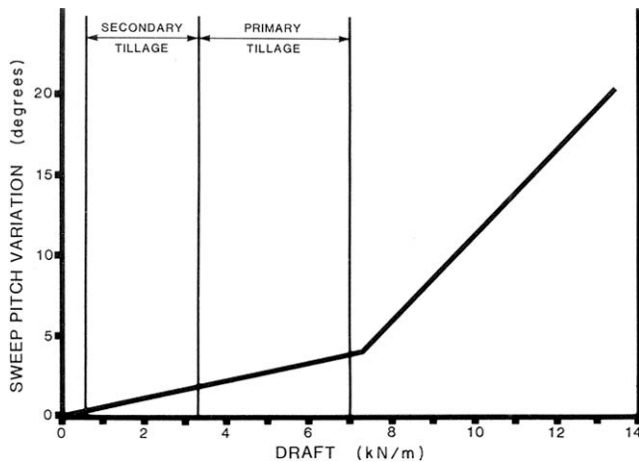
FIGURE 3. Sweep Pitch Variation over a Normal Range of Draft (305 mm shank spacing).

FIGURE 3 shows pitch characteristics of the Wil-Rich 13CPW shank assembly. The low end of the pitch curve results from shank flexing while the steeper part is due to cushioning spring deflection. Sweep pitch varied about 4 degrees over the full range of draft normally occurring in primary tillage. When equipped with 43 degree sweeps, as used during the test, sweep pitch varied from 2 to 6 degrees over the normal draft range. At the manufacturer's recommended setting, shank spring preload was exceeded and tripping occurred at drafts greater than 7.3 kN/m (500 lb/ft), as shown on the graph. Tripping occurred beyond the normal primary tillage draft range, indicating the Wil-Rich 13CPW spring cushioned shanks are adequate for heavy primary tillage.

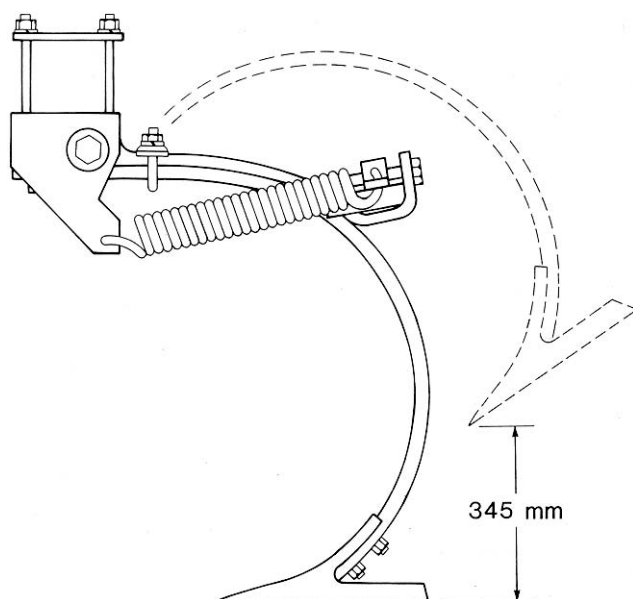
FIGURE 4. Shank Lifting Pattern.

FIGURE 4 shows the lifting pattern when shanks encounter stones or field obstructions. Maximum lift height was 345 mm (13.5 in). One shank bent and one sweep broke during the 154 hour test period. The spring cushioned shank holders performed well during the test and the failures that occurred do not represent a serious problem.

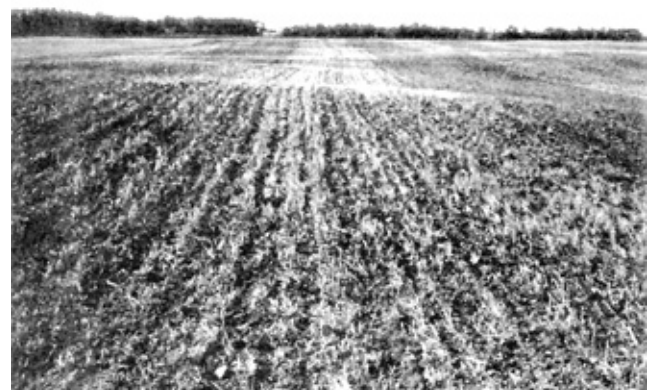
FIGURE 5. Typical Trash Burial with Chisel Points.

Trash burial with chisel points in heavy crop residue was good (FIGURE 5). The action of the chisel points moved enough soil for adequate trash burial while leaving some standing stubble for snow retention.

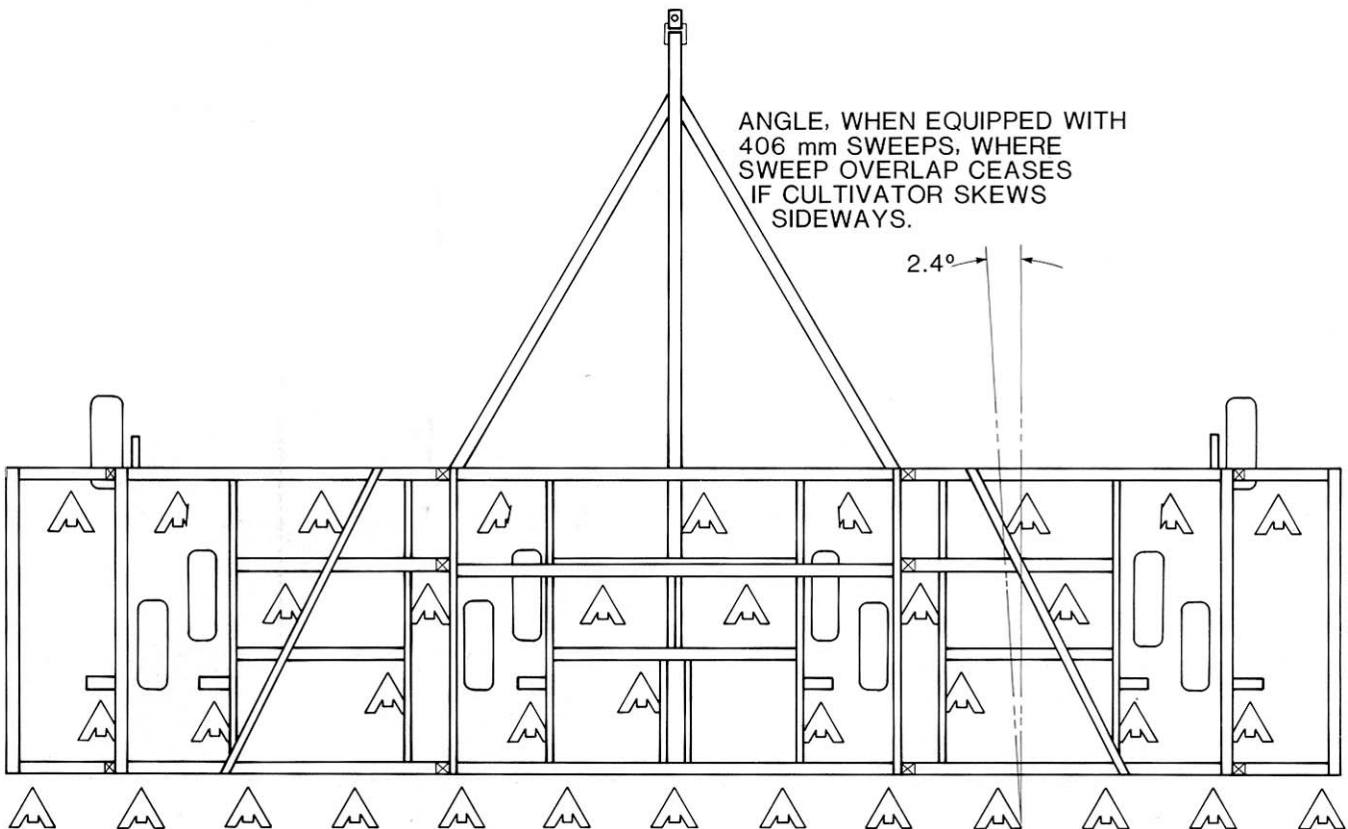
FIGURE 7. Sweep Pattern (305 mm shank spacing).

Skewing and Stability: The Wil-Rich 13CPW skewed considerably on side slopes or in heavy draft conditions where soil varied in hardness across the width of the machine. The sweep pattern (FIGURE 7), however, was symmetrical and did not impose any resultant side forces on the cultivator during normal operation. With 406 mm (16 in) sweeps, as used on 33 of the 37 shanks, the cultivator had to skew more than 2.4° for weed misses to consistently occur across the cultivator width. Trimmed sweeps (FIGURE 8) were used on the 4 shanks adjacent to the wheels, and the cultivator had to skew only minimally for weed misses to occur at these locations. Moderately hilly ground caused sufficient sideways skewing for frequent weed misses by the trimmed sweeps.

It is recommended that shanks be arranged on the cultivator to avoid the use of trimmed sweeps adjacent to wheels.

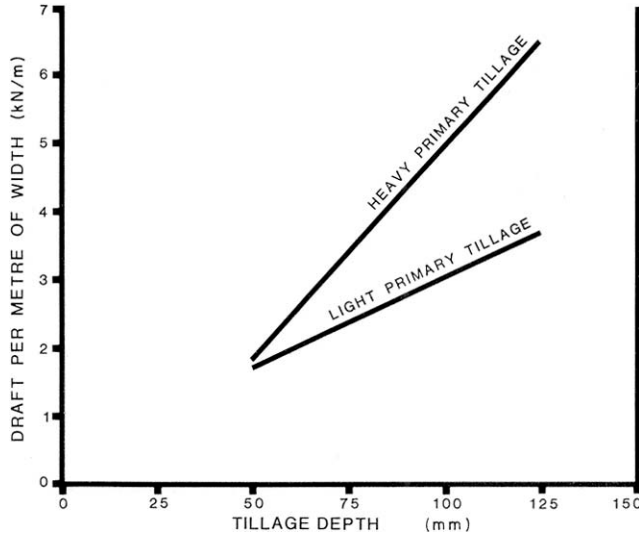
FIGURE 11. Average Draft Requirements for Heavy Duty Cultivators at 8 km/h.

Draft Characteristics: FIGURE 11 shows draft requirements for heavy duty cultivators in typical primary tillage, at a speed of 8 km/h (5 mph). This figure gives average requirements based on tests of 10 makes of heavy duty cultivators in 40 different field conditions. Attempting to compare draft requirements of different makes of heavy duty cultivators usually is unrealistic. Draft requirements for the same cultivator, in the same field, may vary by as much as 30% in two different years, due to changes in soil conditions. Variation in soil conditions affect draft much more than variation in machine make, usually making it impossible to measure any significant draft differences between different makes of heavy duty cultivators.

In heavy primary tillage, average draft per metre of width, at 8 km/h (5 mph), varied from 1.8 kN (123 lb/ft) at 50 mm (2 in) depth to 6.5 kN (440 lb/ft) at 125 mm (5 in) depth, corresponding to a total draft from 20.5 to 74.1 kN (4600 to 16,600 lb) for the 11.3 m (37 ft) test machine.
